Horizontal Top Side Shallow Repair

Repair Method:
C1-SC01

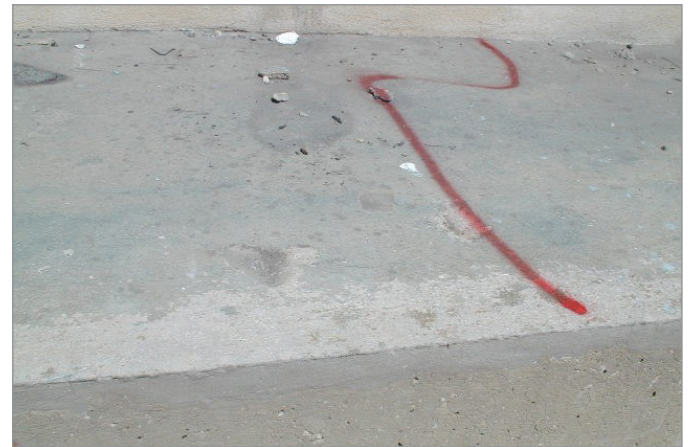
Deteriorated, surface spalling concrete with no exposed and / or rusting steel reinforcement.
