Horizontal Under Side Shallow Repair

Repair Method:
C1-SC03

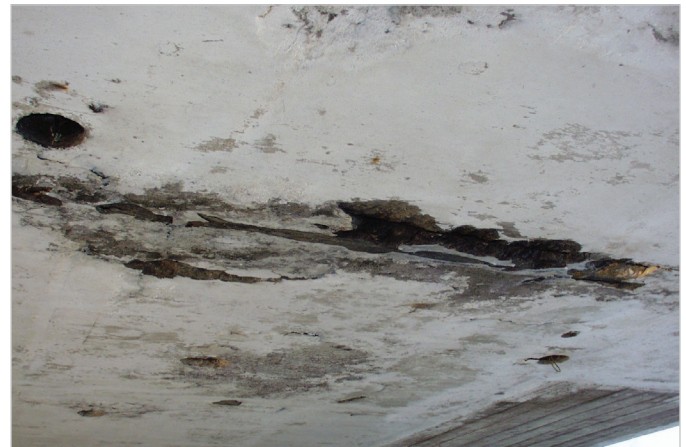
Deteriorated, surface spalling concrete with no exposed and / or rusting steel reinforcement.
